**DEPARTMENT OF PUBLIC WORKS
ENGINEERING DIVISION**

2024 Geologic Hazard Abatement District (GHAD) Maintenance

EXHIBIT D

Representative Photographs

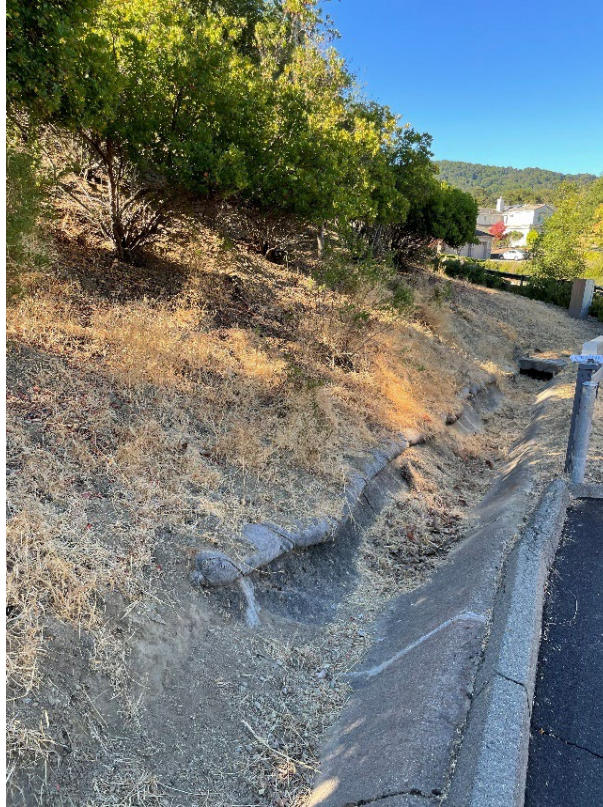
ID LC-9: Soil slumping into concrete drainage ditch and drain inlet.

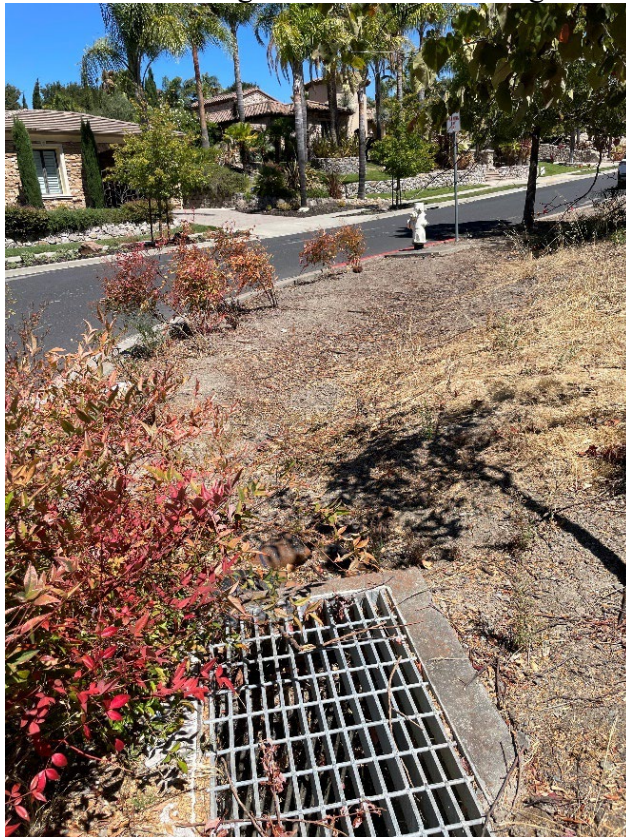
ID LC-10: Slow drainage of catch basin during rain events.

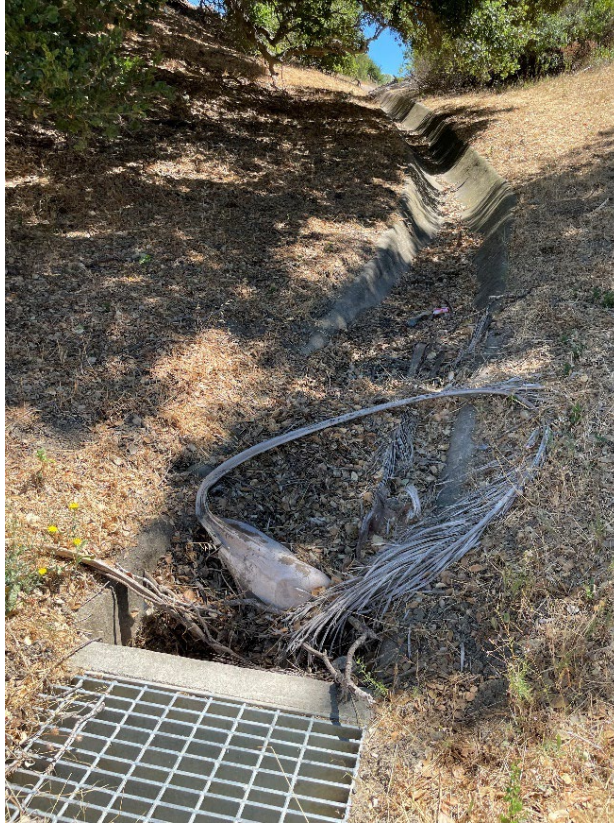
ID LC-13: Slow drainage of catch basin during rain events. Leaves, branches debris around catch basin.

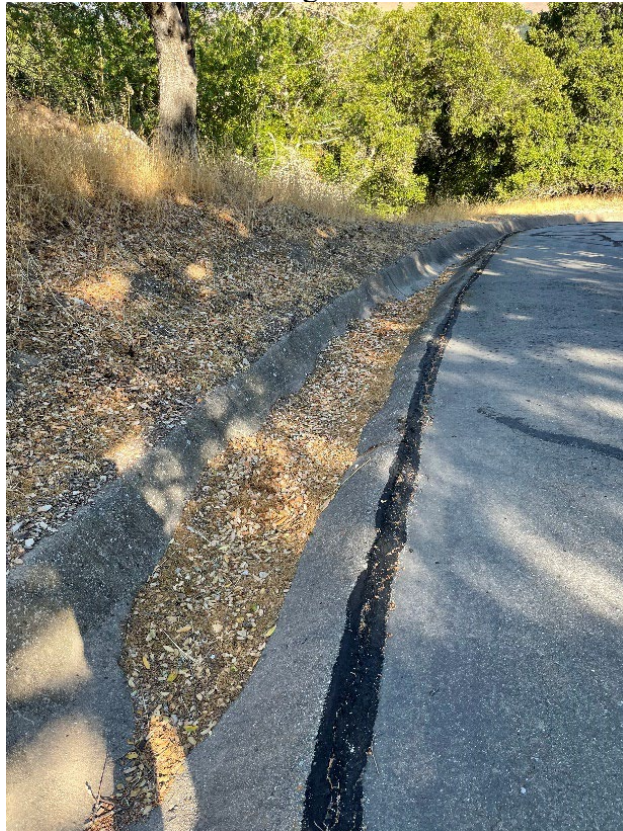
ID LC-14: Leaves accumulating in concrete-lined drainage ditch.

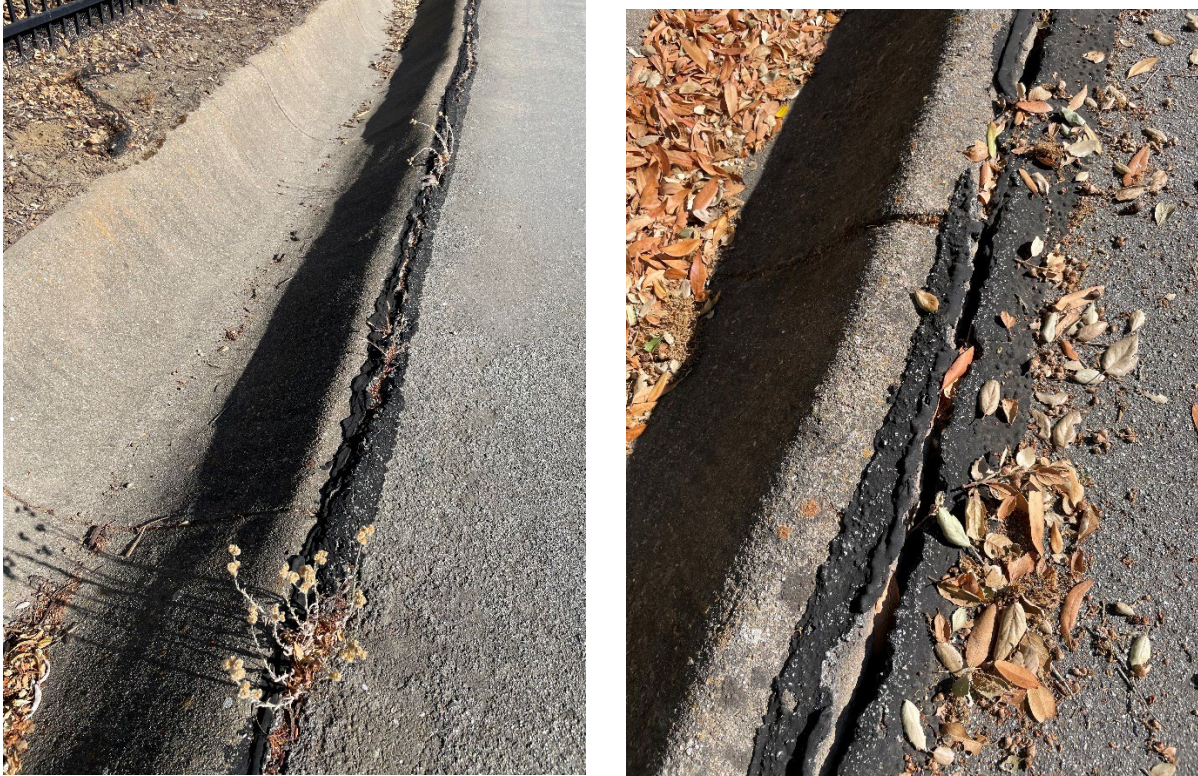
ID LC-15: Expansion joint in pavement along concrete-lined drainage ditch.

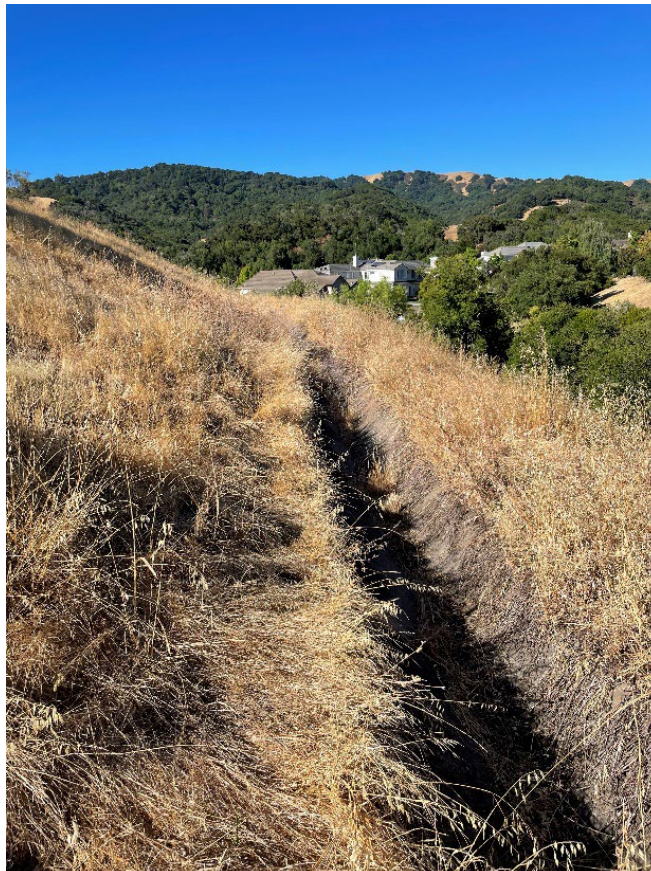
ID LC-18: Overgrown vegetation on sides of V-ditch. Leaves and grass accumulated in concrete-lined drainage ditch.

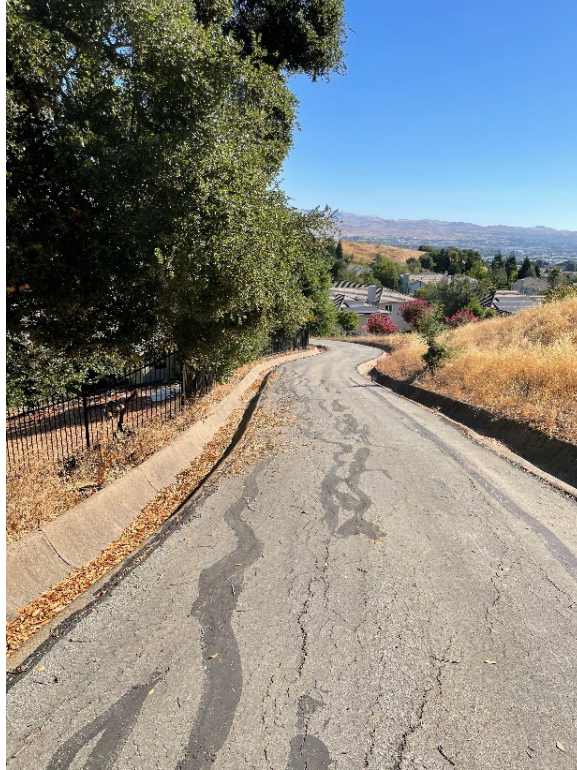
ID LC-22: Cracking and distress on access road.

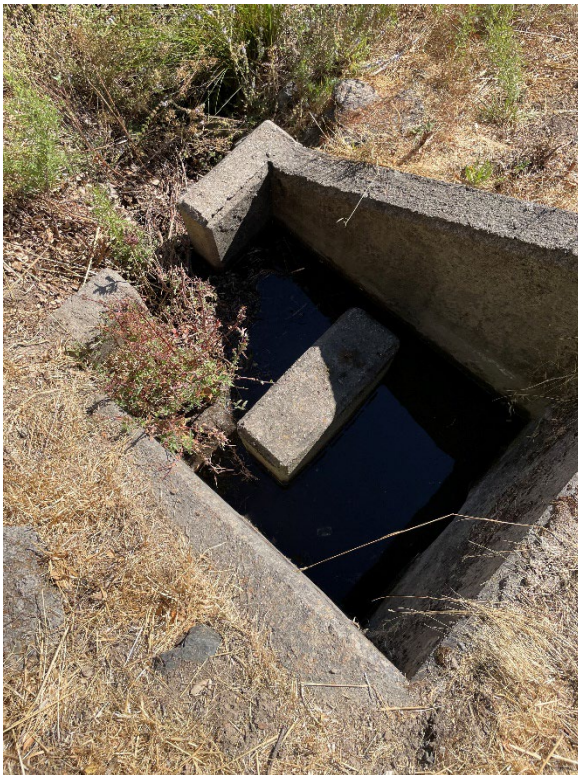
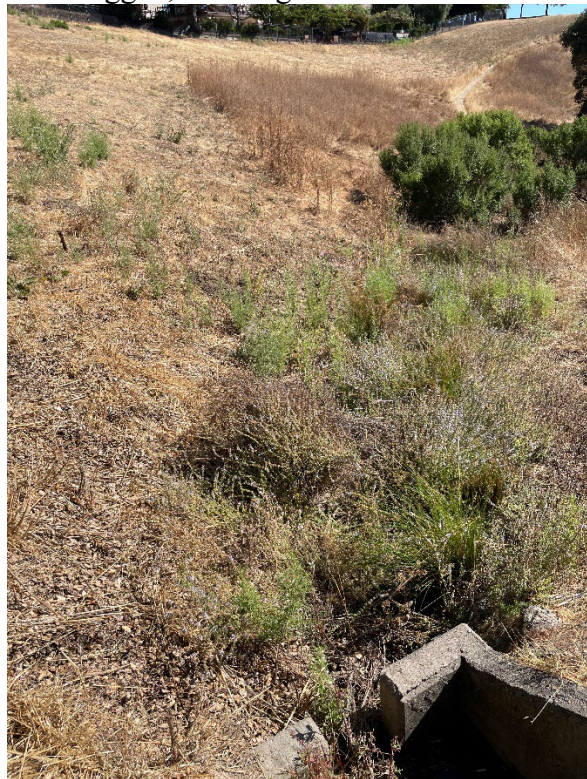
ID LC-23: Drainage inlet in open space is clogged, standing water in DI.

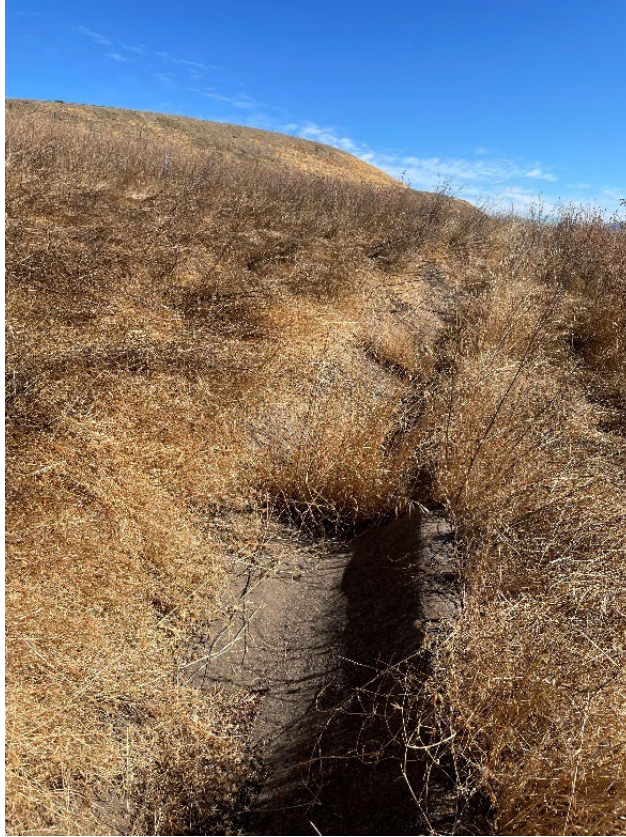
ID LC-32: Concrete drainage ditch overgrown with grasses and weeds, soil accumulated in v-ditch

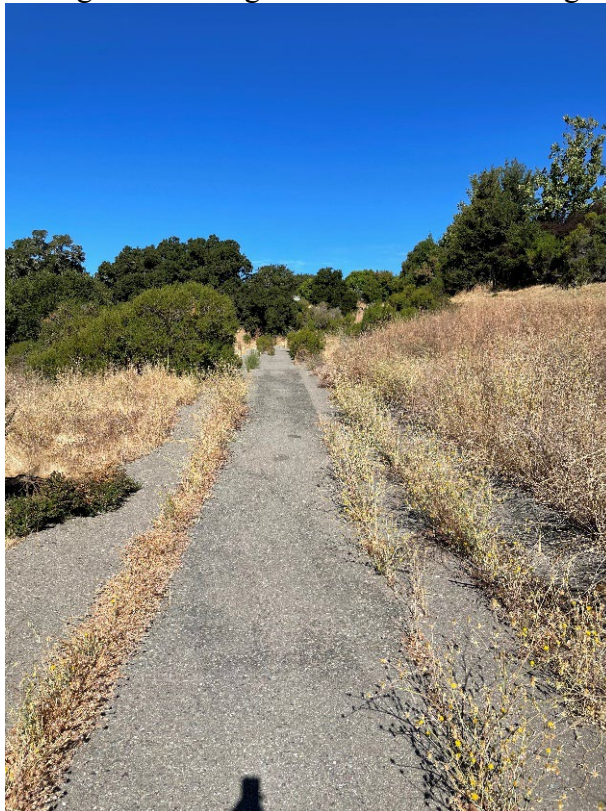
ID LC-35: Grasses and vegetation overgrown in concrete drainage ditch and access road.

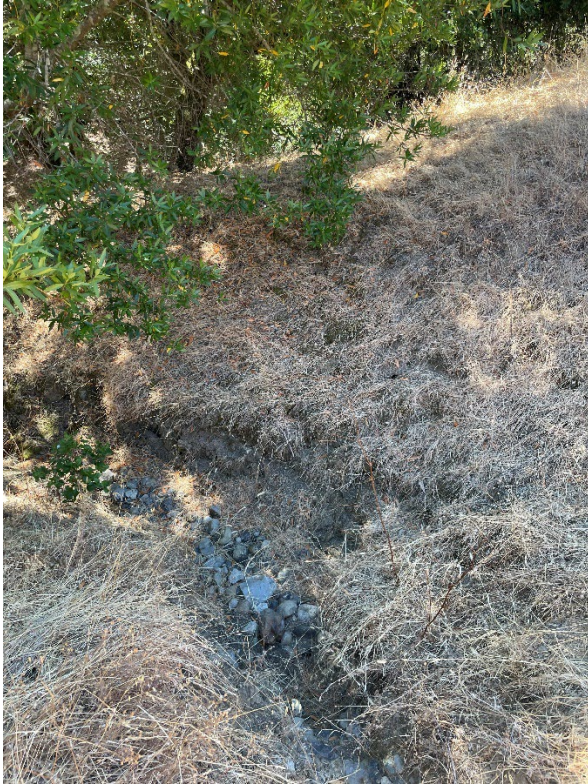
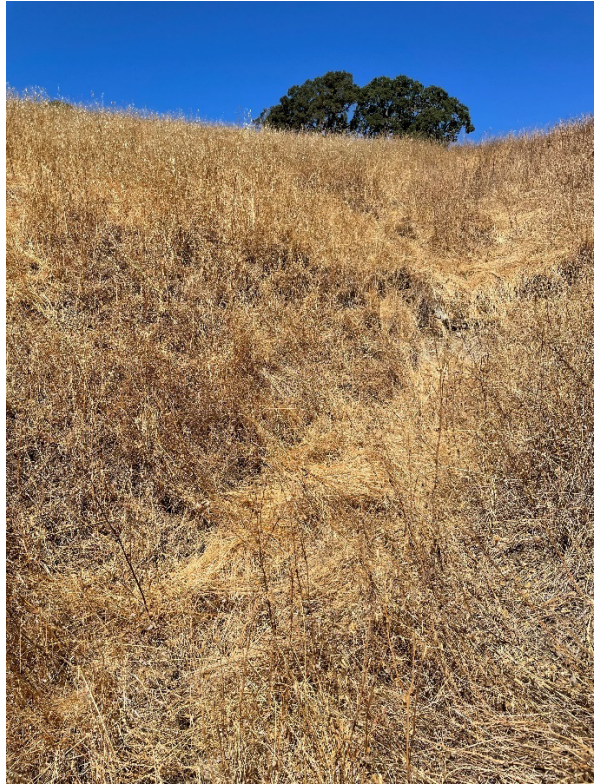
ID LC-36: Erosion at outfall of SD-11, area overgrown with dense grasses and weeds.

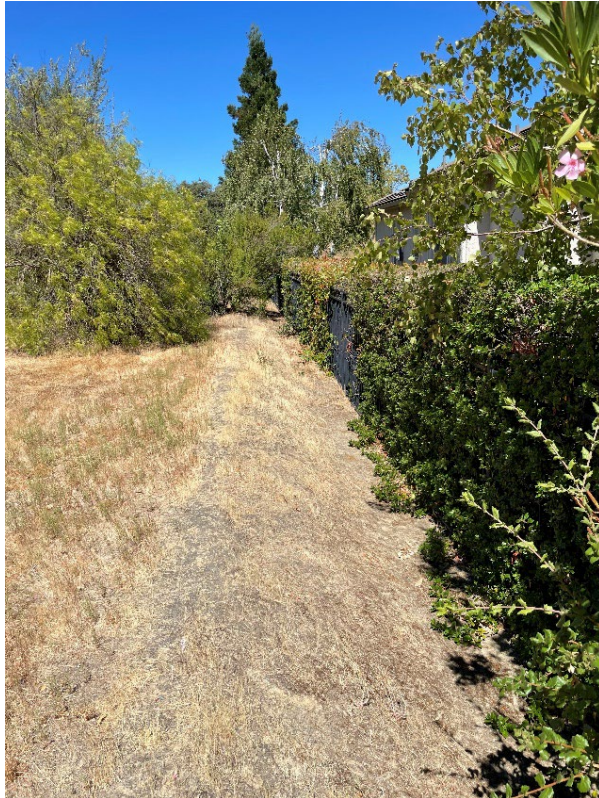
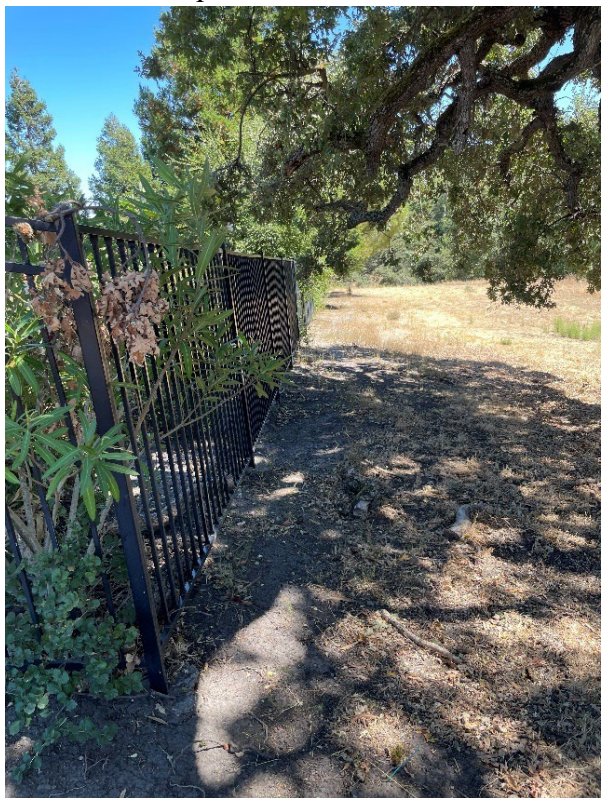
ID LC-37: New Concrete V-Ditch Required

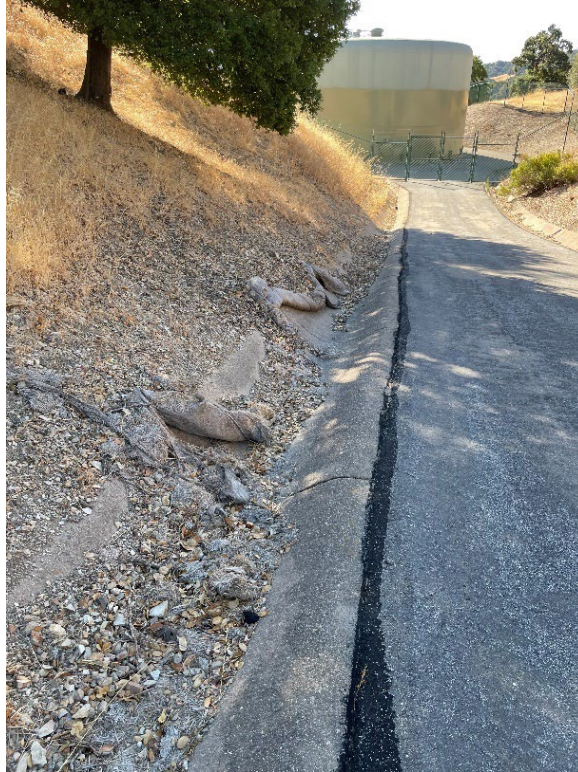
ID LC-39: Straw wattle damaged.

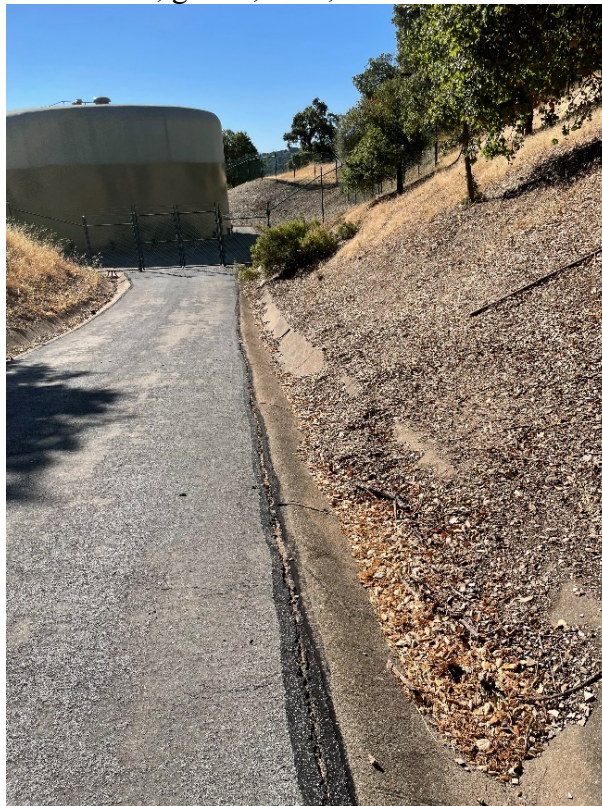
ID LC 40: Debris, gravel, soils, leaves in Concrete V-Ditch

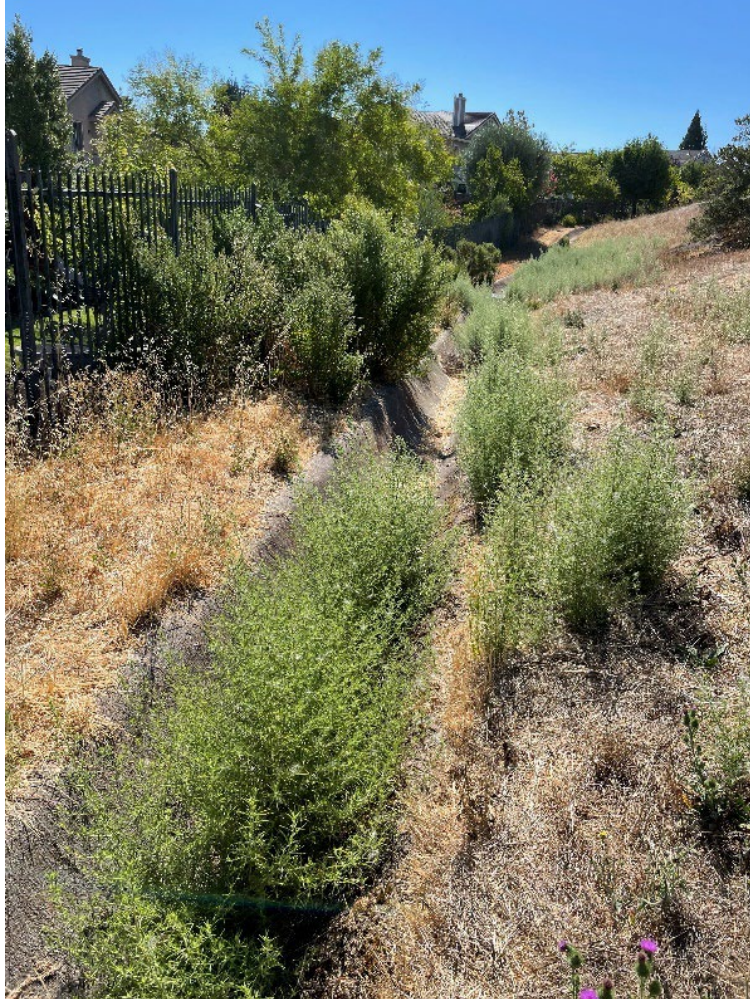
ID LC 43: Debris & Trimmed grasses accumulated in concrete-lined drainage ditch.

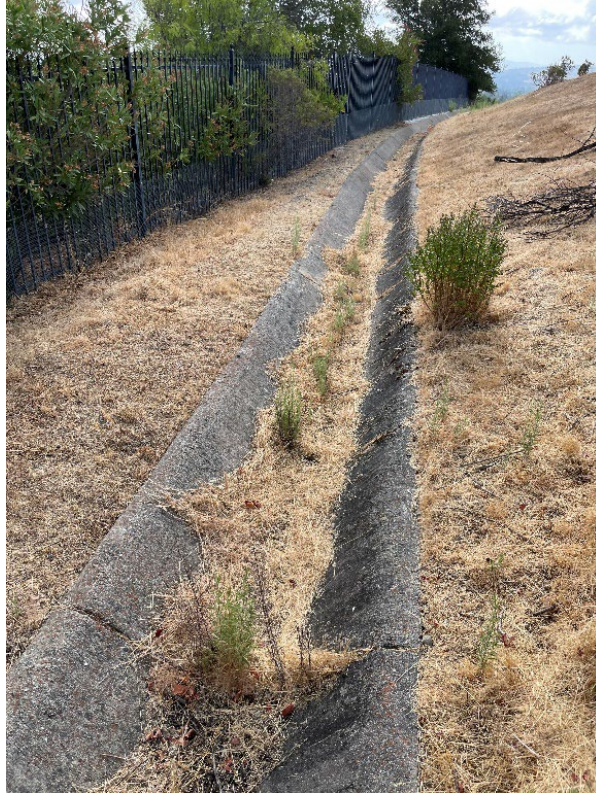
ID MR-3: Leaves, grass & debris accumulated in concrete drainage ditch for entire v-ditch.

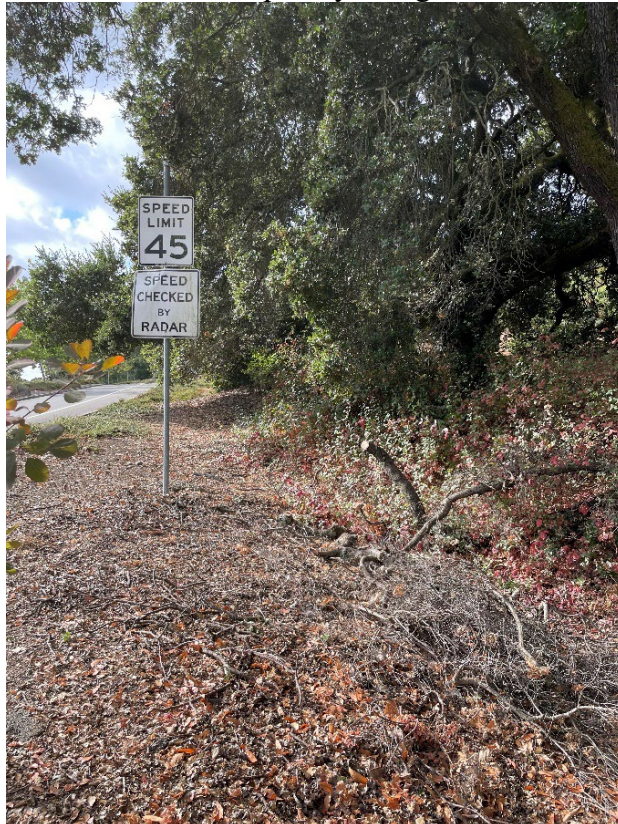
ID MR-4: Earthen swale completely overgrown and filled with soil.

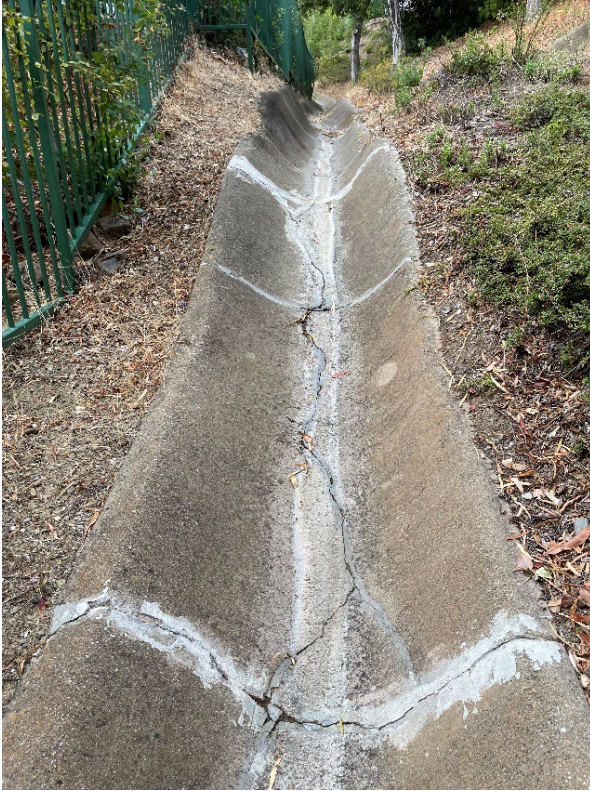
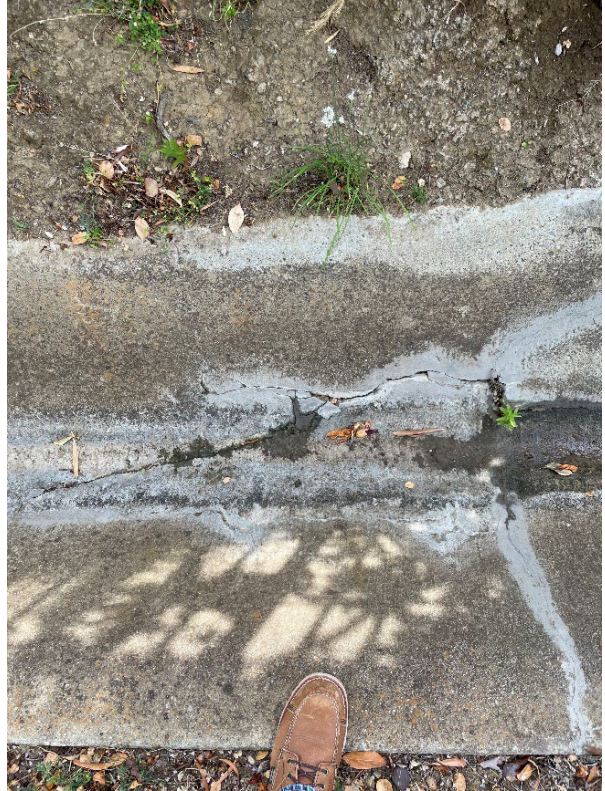
ID MR-6: Cracking in concrete-lined drainage ditch.

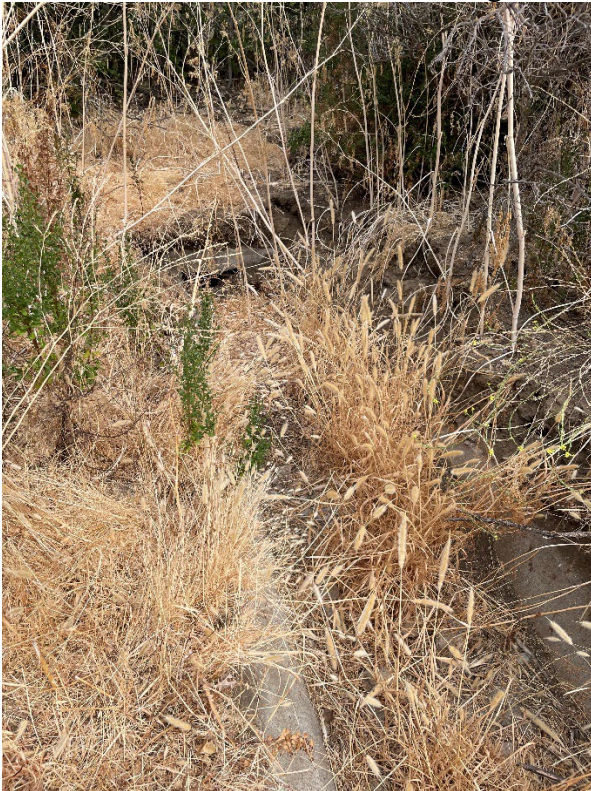
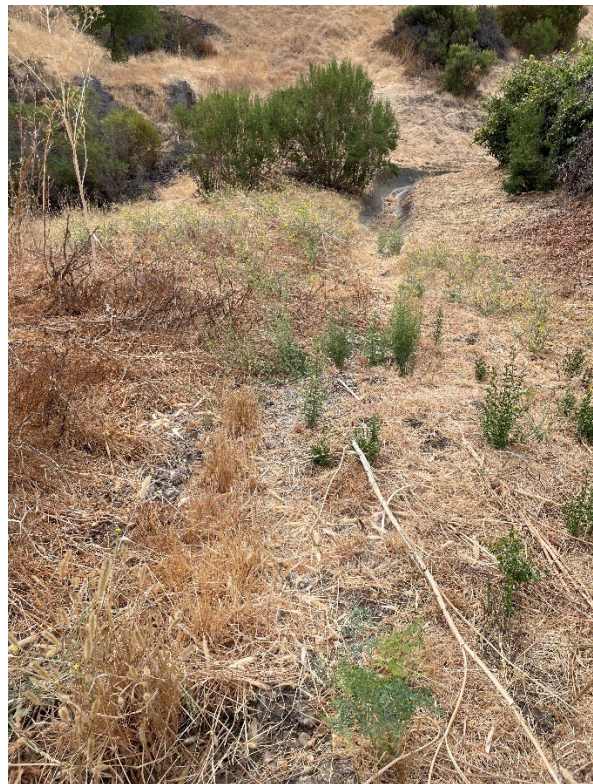
ID MR-9: Ditch segment buried with soil and vegetation.

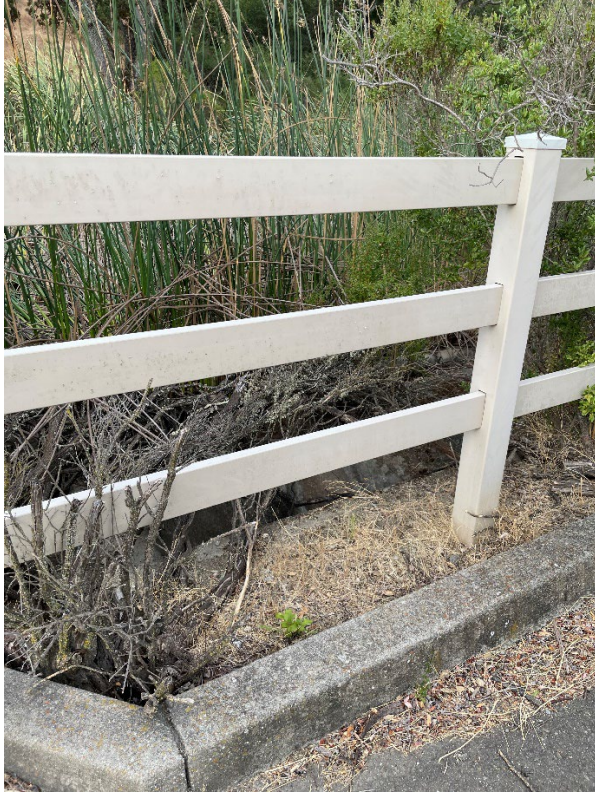
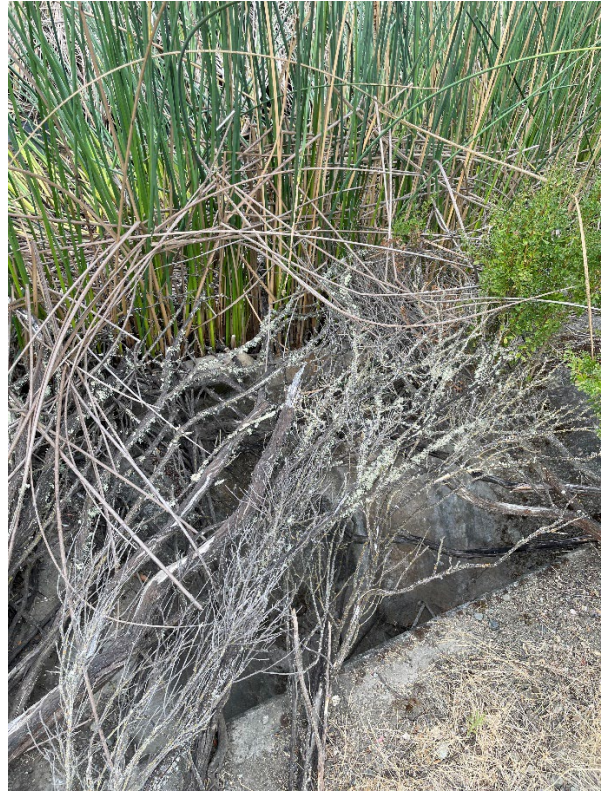
ID MR-12: Outfall in pond overgrown and inlet clogged.

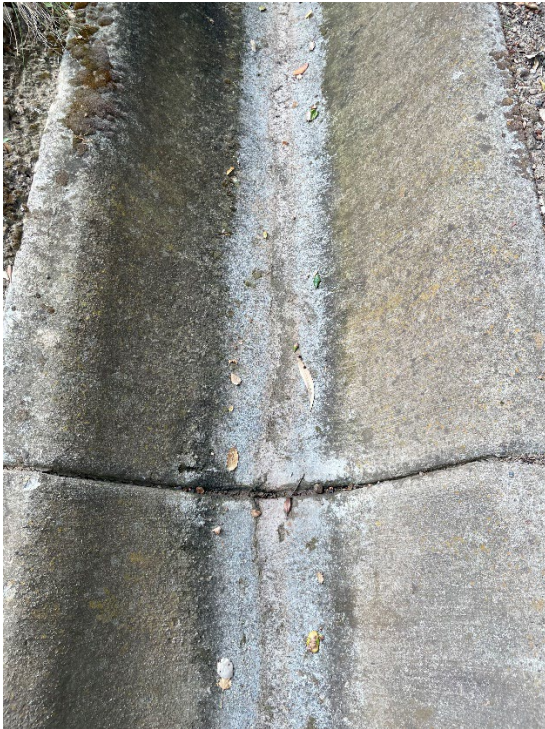
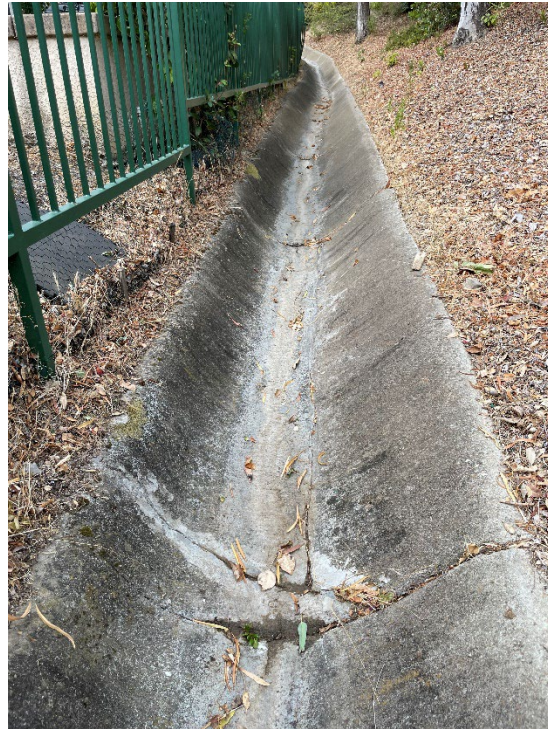
ID MR-18: Cracking and offset in concrete-lined drainage ditch. Soil accumulated in concrete-lined drainage ditch.

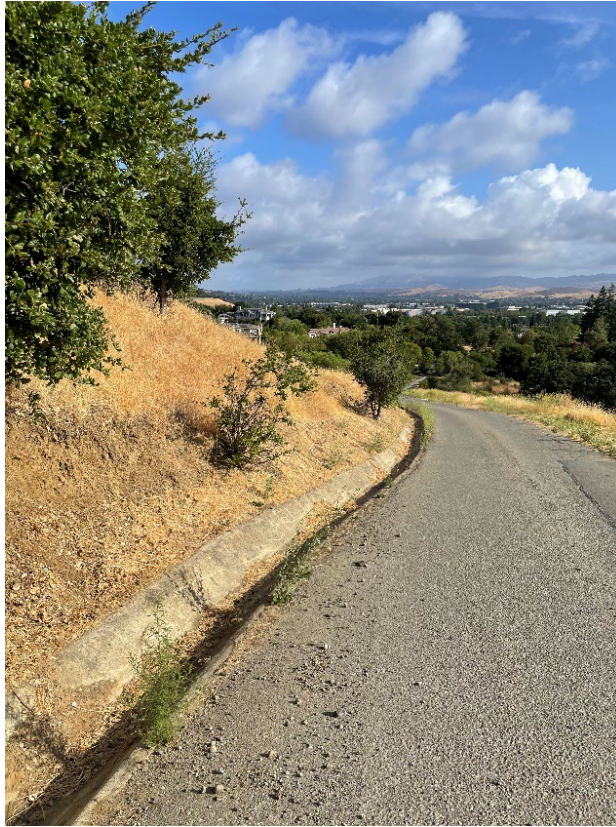
ID MR-21: Vegetation overgrown, trimmed grass leaves and debris accumulated in concrete-lined drainage ditch.

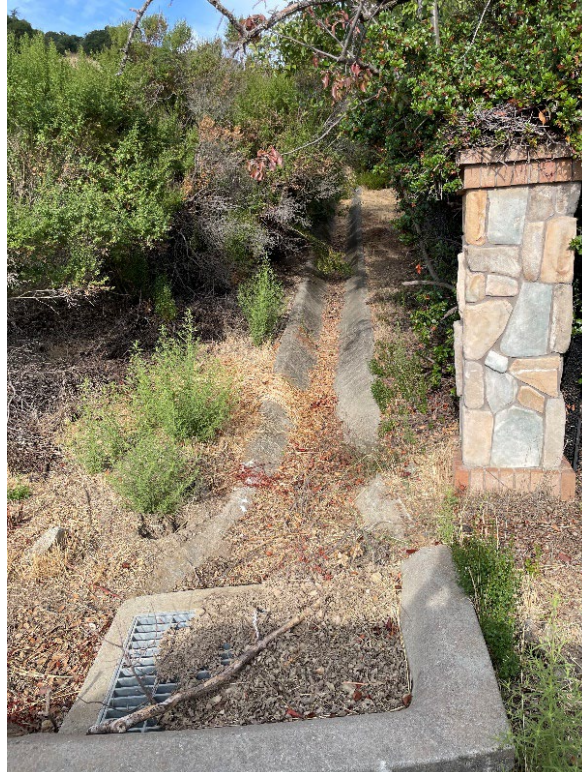
ID MR-22: Debris, branches inside DI/CB.

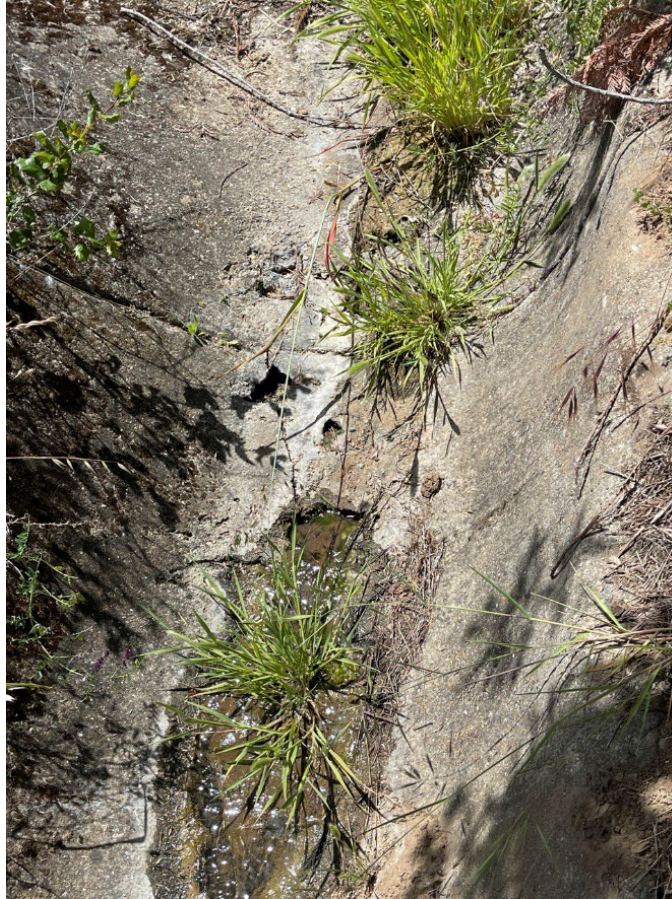
ID MR-25: Cracking in concrete drainage ditch allowing water to actively flow under ditch.

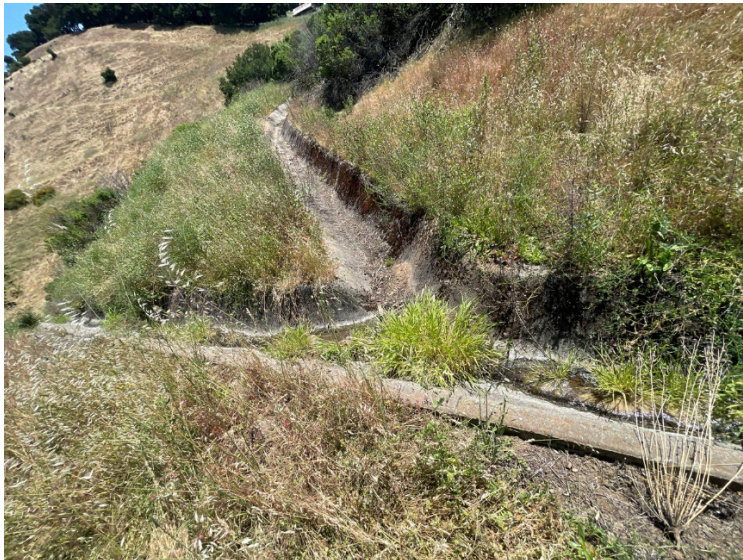
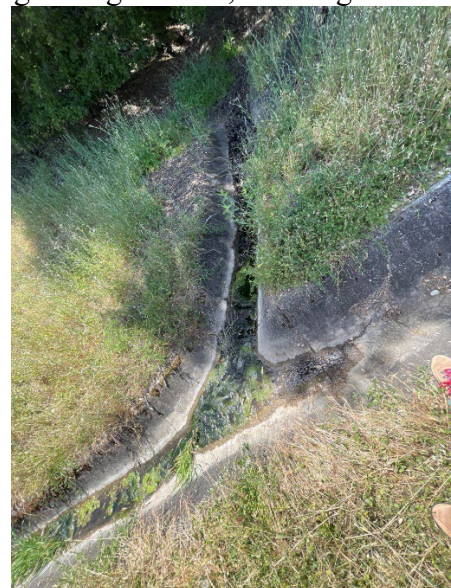
ID MR-26: Concrete drainage ditch blocked with vegetation growing through cracks, standing water in ditch.

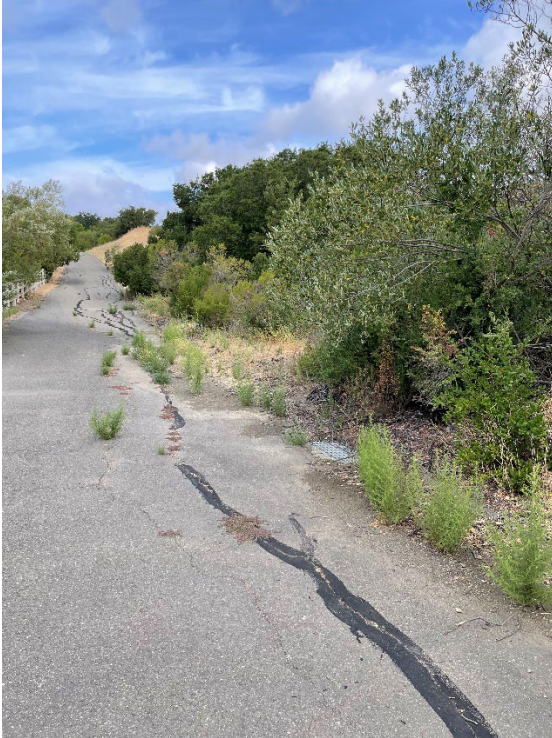
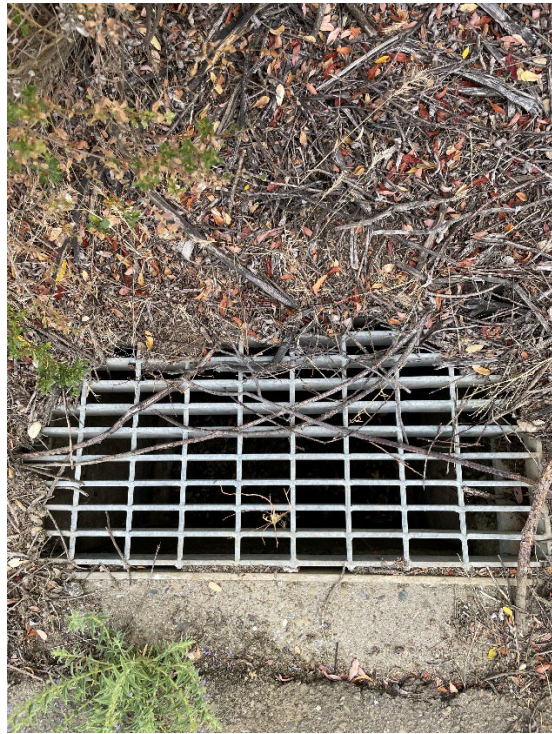
ID MR-30: Debris accumulated at drain inlet on north side of road.

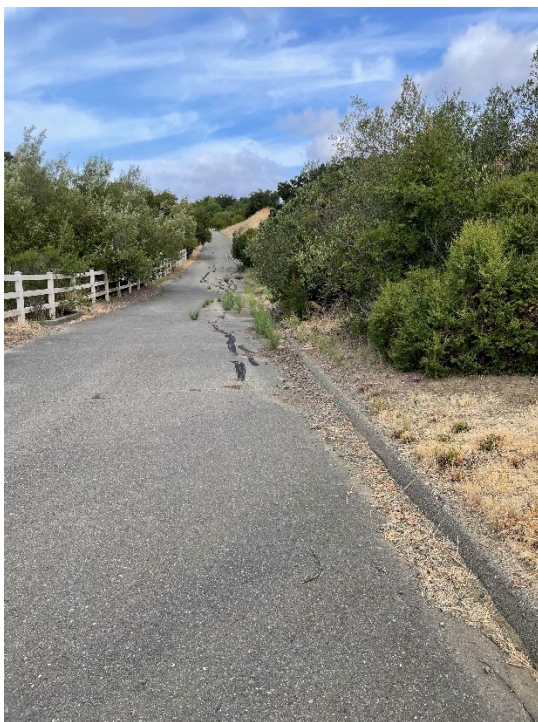
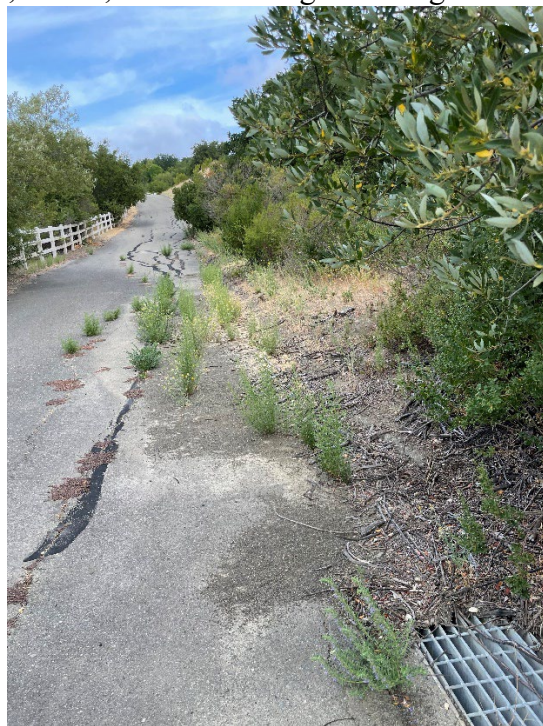
MR 31: Road on north side has debris, leaves, soil etc.. Along curb long.

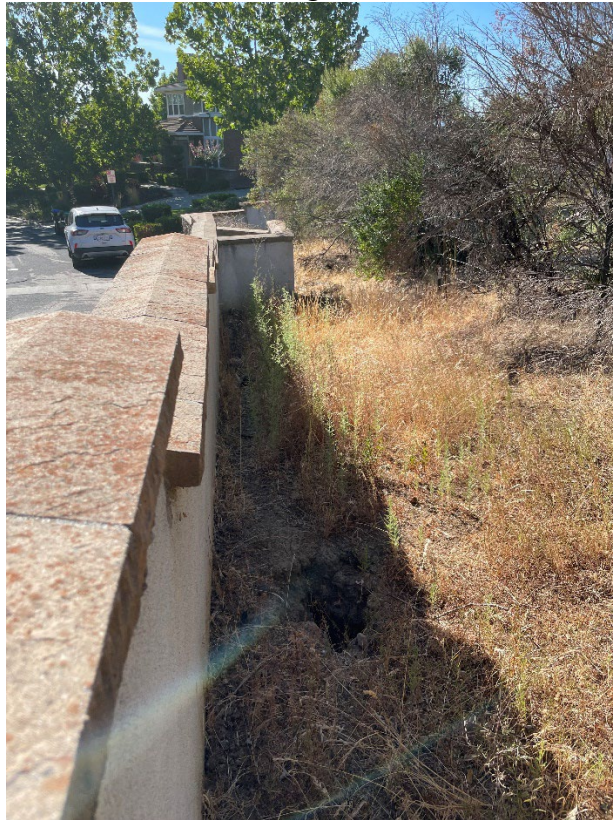
ID LR-1: Animal burrowing created a void behind wall.

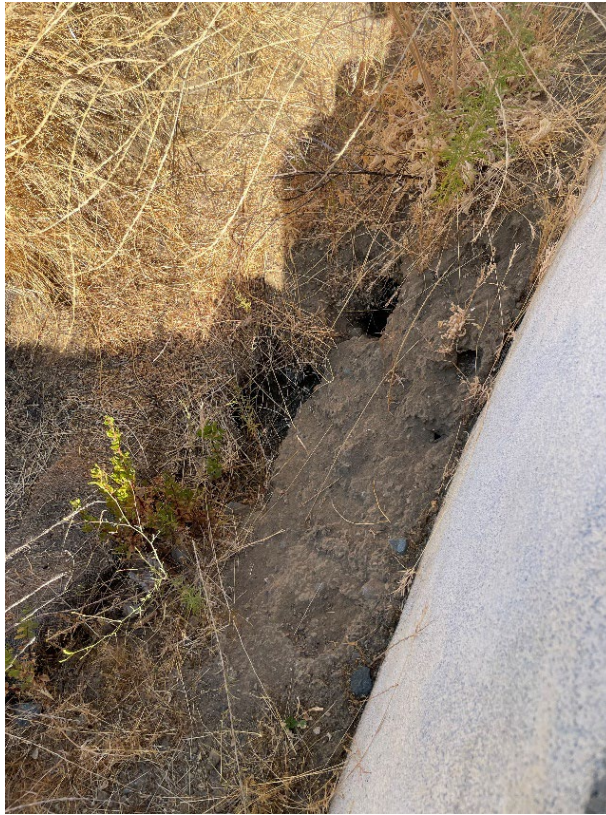
ID LR-2: Excessive burrowing and erosion exposing footing of wall

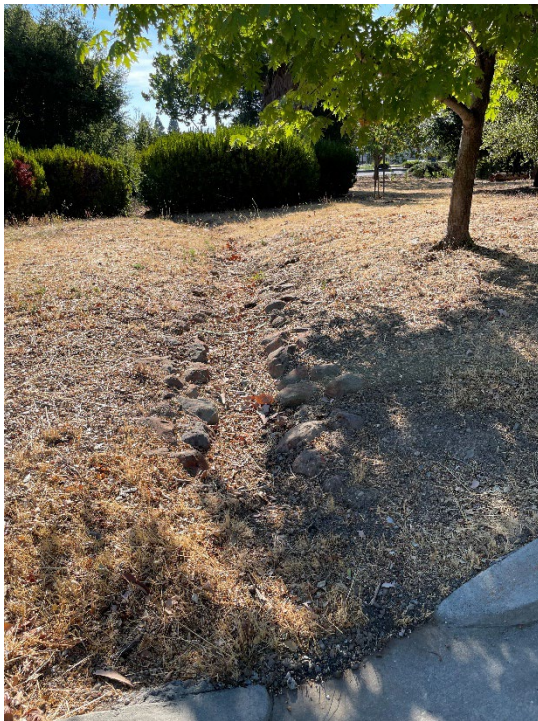
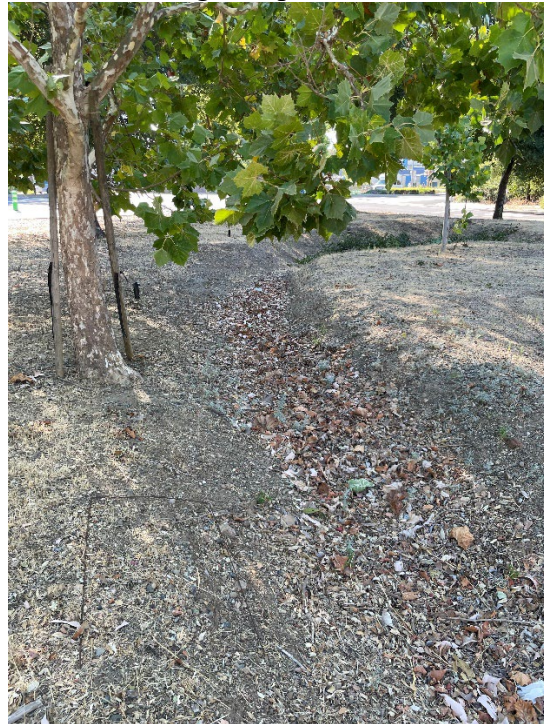
ID LR-7: Existing grade does not drain to gutter pan.

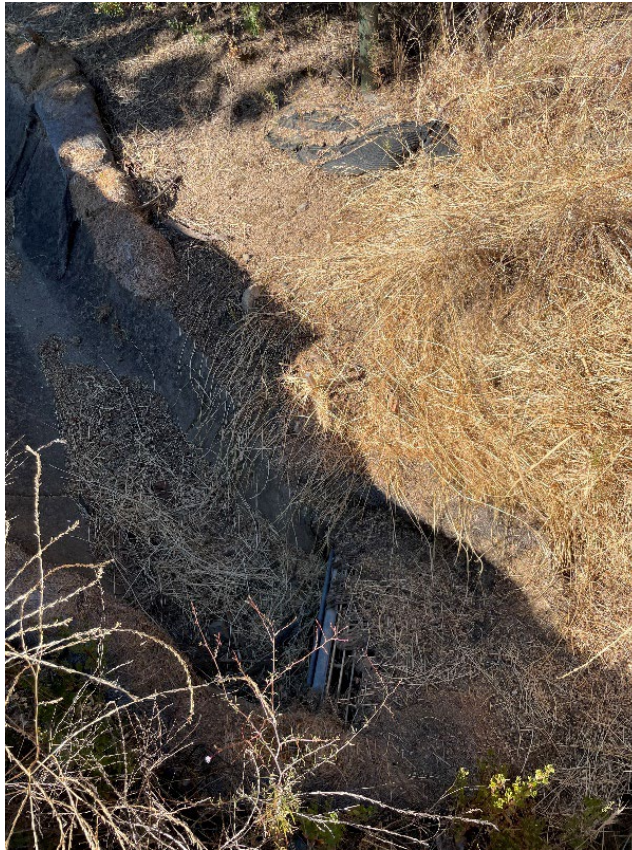
ID LR-13: Deep erosion gully and collapsing soil along wall. Debris around and inside drain inlet.

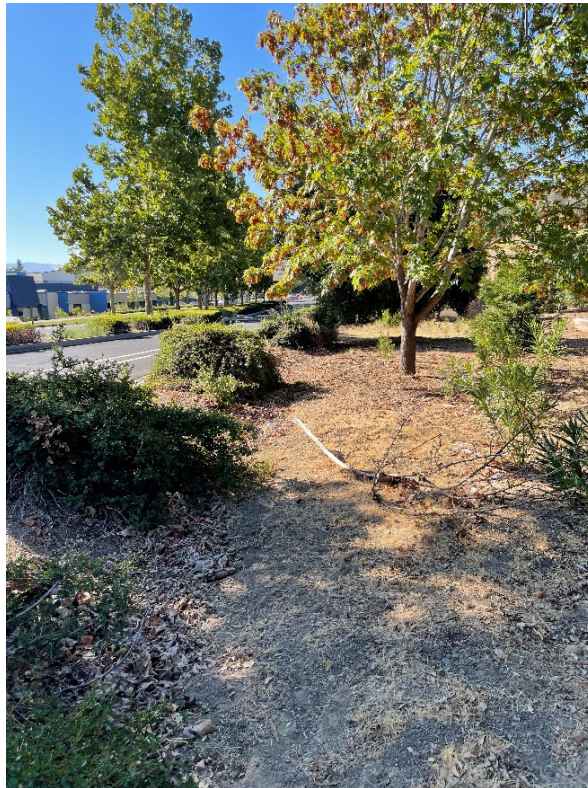
ID LR-16: Leaves and branches accumulated in earthen ditch.

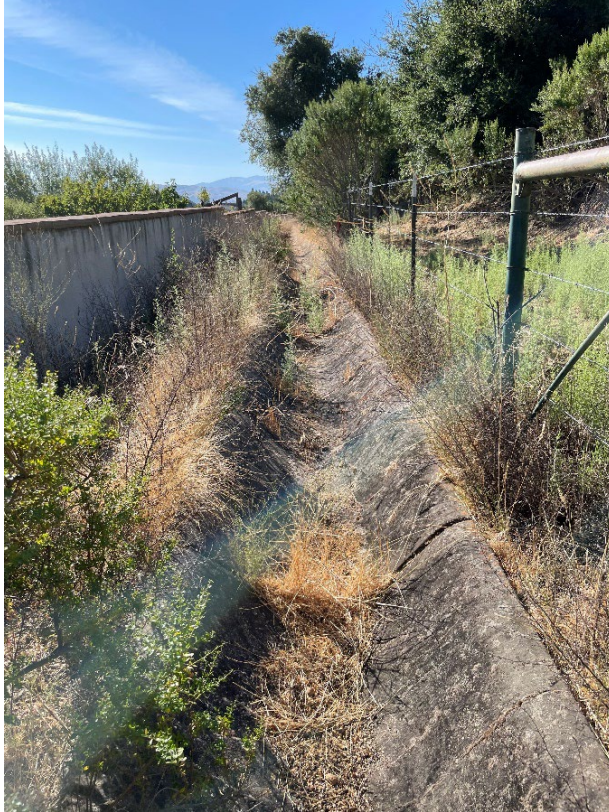
ID LR-17: Overgrown vegetation along drainage ditch.

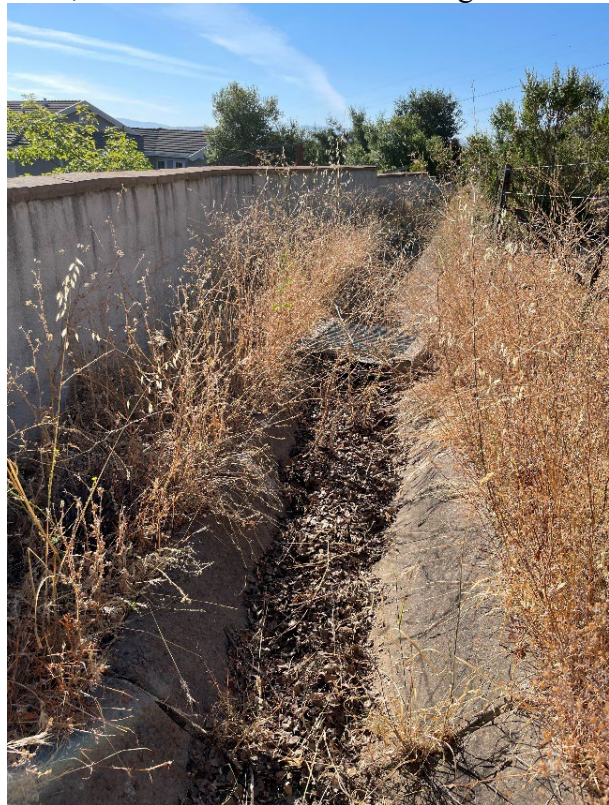
ID LR-18: Debris, weeds, leaves accumulated in drainage ditch. For majority of V-ditch

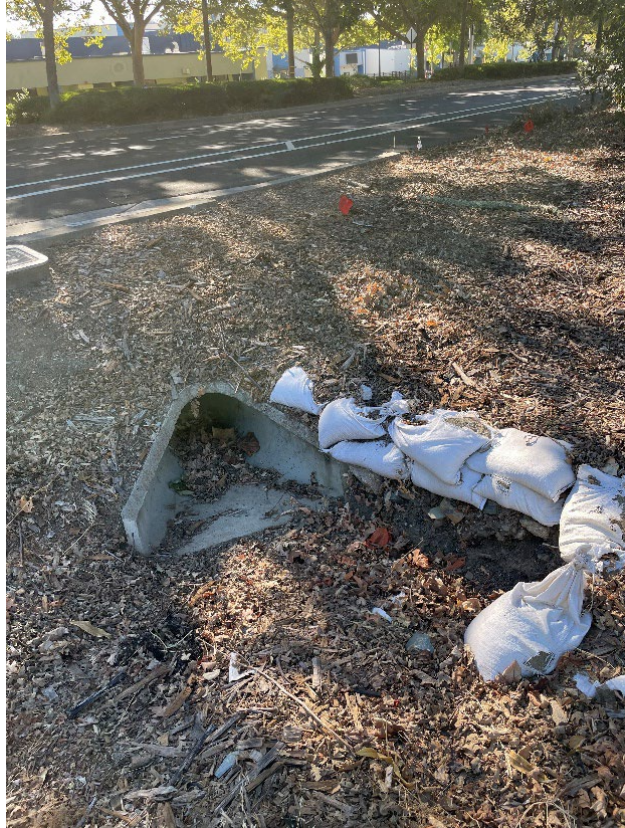
ID LR-19: Sand bags installed around field inlet
