**DEPARTMENT OF PUBLIC WORKS
ENGINEERING DIVISION**

2024 Geologic Hazard Abatement District (GHAD) Maintenance

EXHIBIT D

Representative Photographs

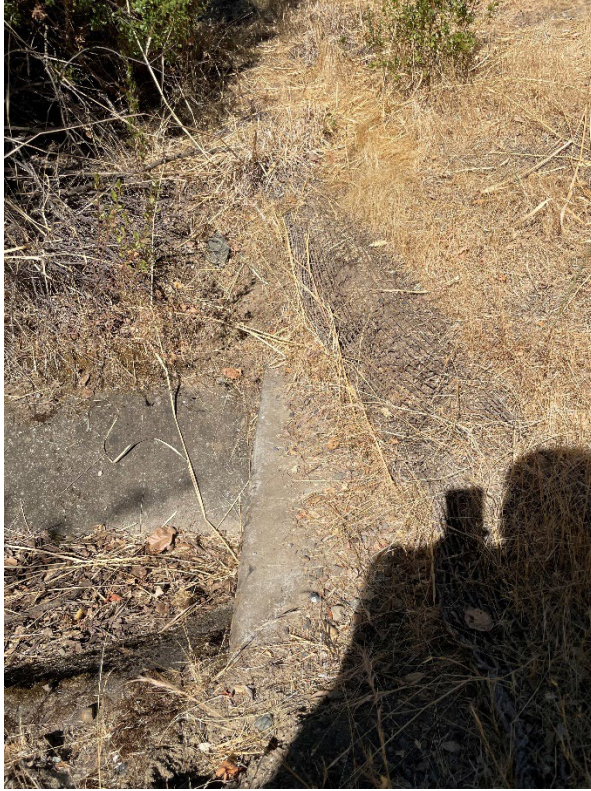
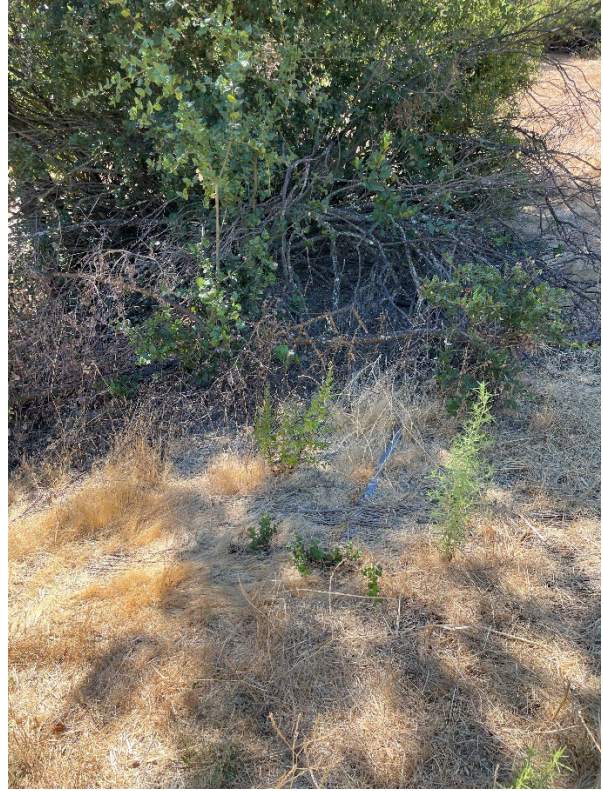
ID OTF-1: Erosion rill on slope and access road, jute fabric placed on slope for erosion control.

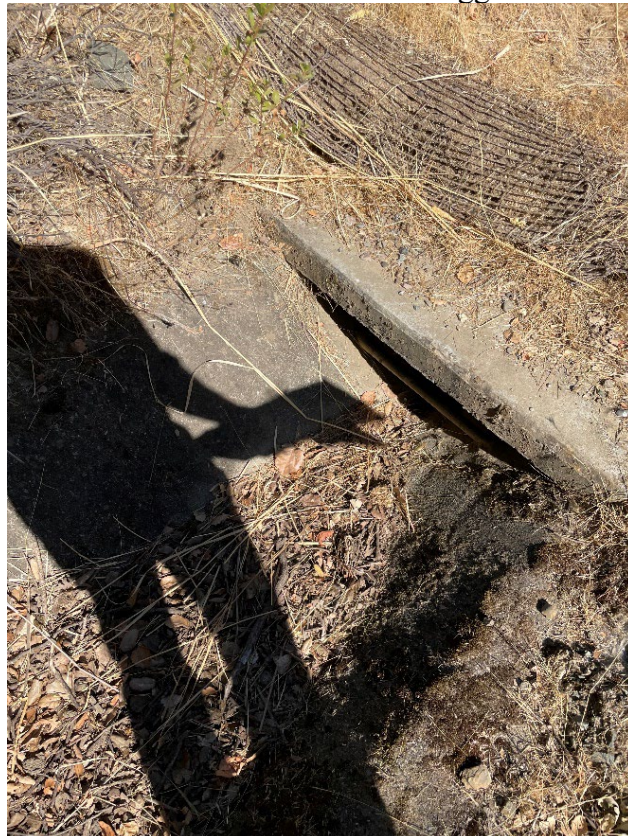
ID OTF-2: Storm drain clogged.

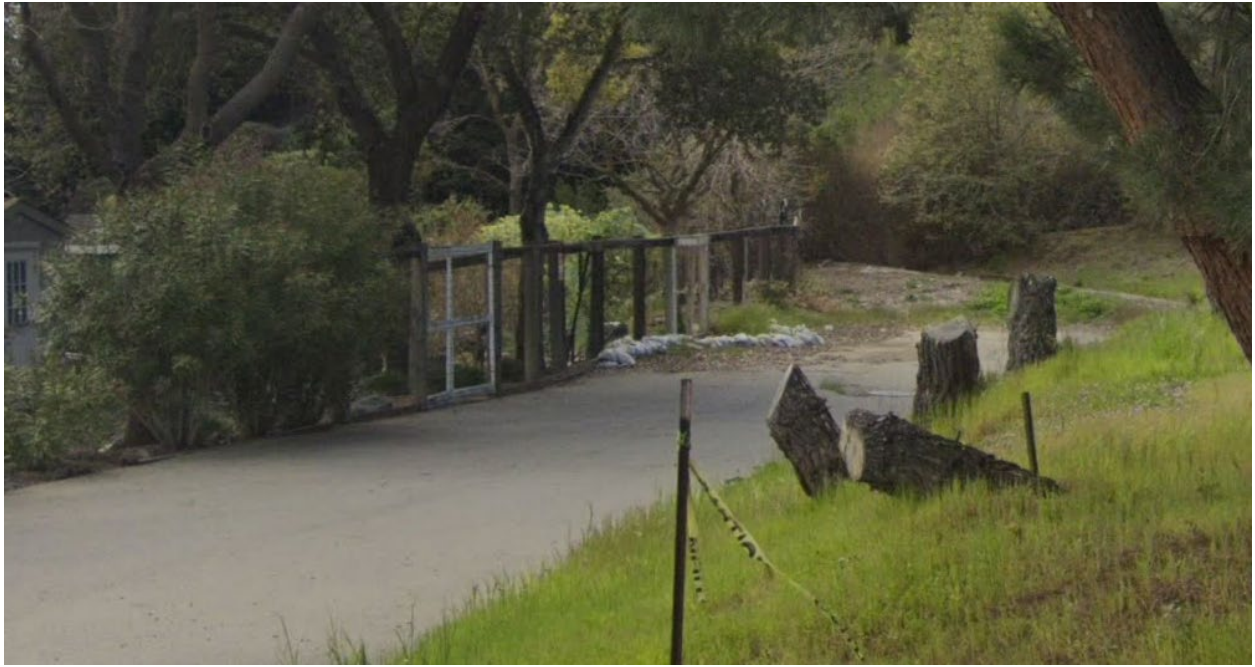
ID OTF-4: Current sandbags runoff directly from private access road above FI#2. Steep Hill

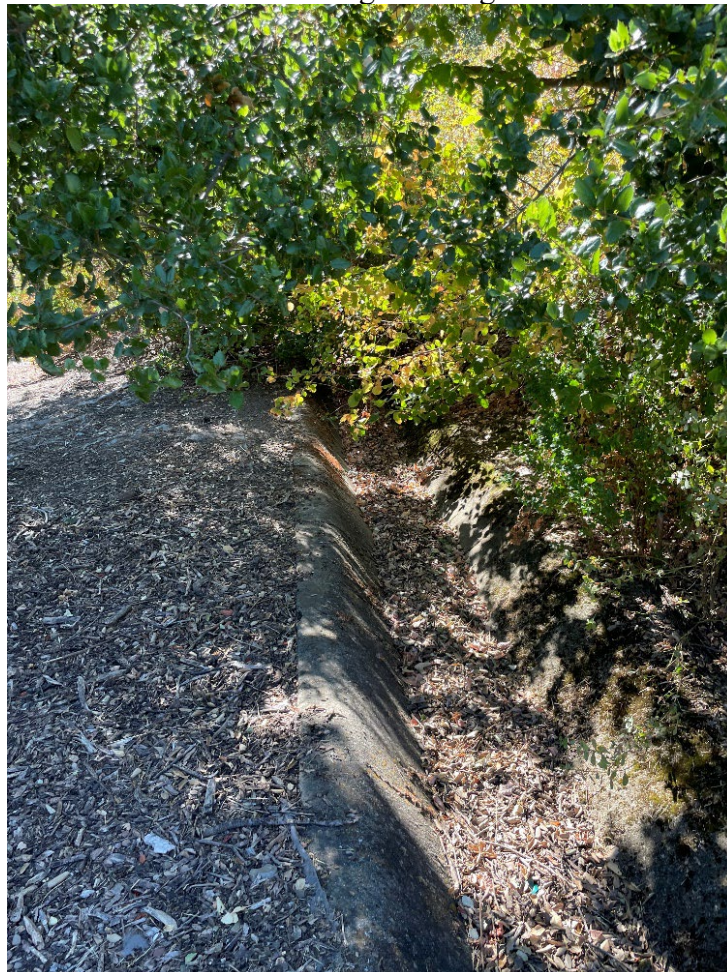
ID OTF-5: Overgrown vegetation.

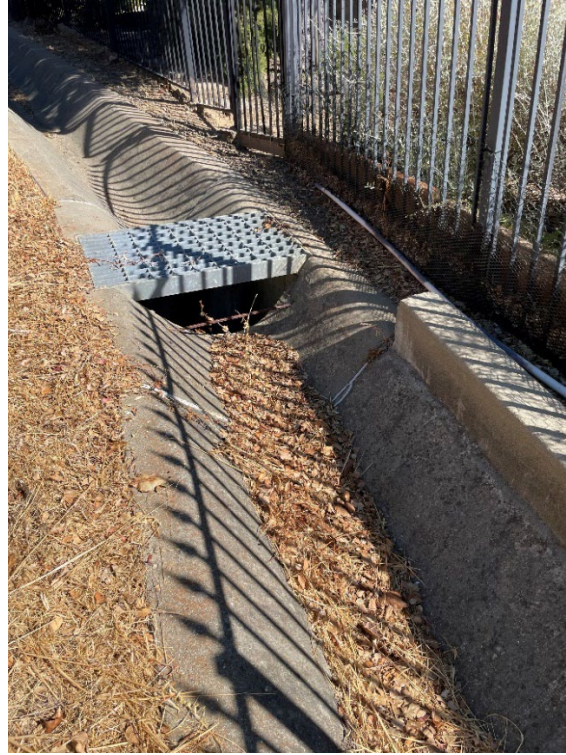
ID OTF-6: Degraded wattle along drainage ditch. Debris in V-ditch

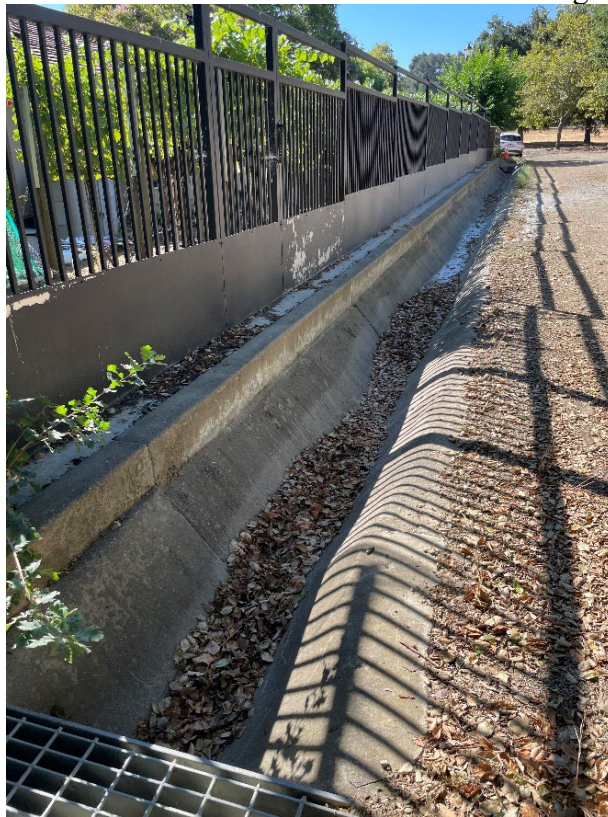
ID OTF-7: Leaves and soil accumulated in drainage ditch.

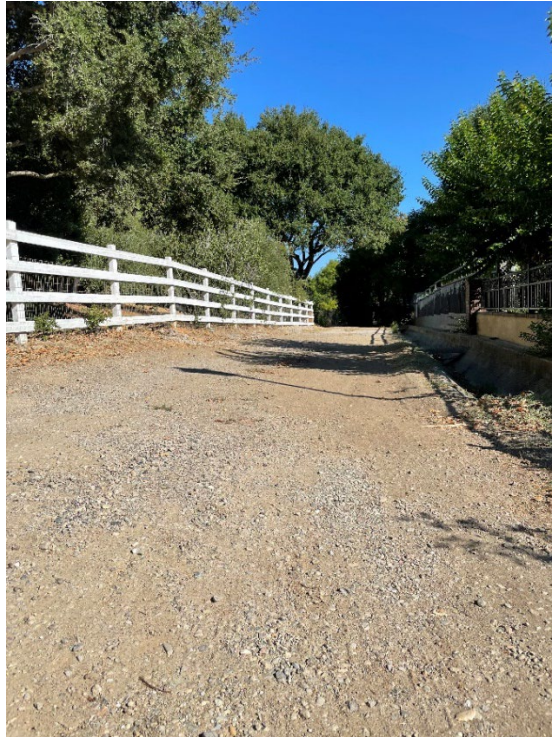
ID OTF-8: Access road erosion.

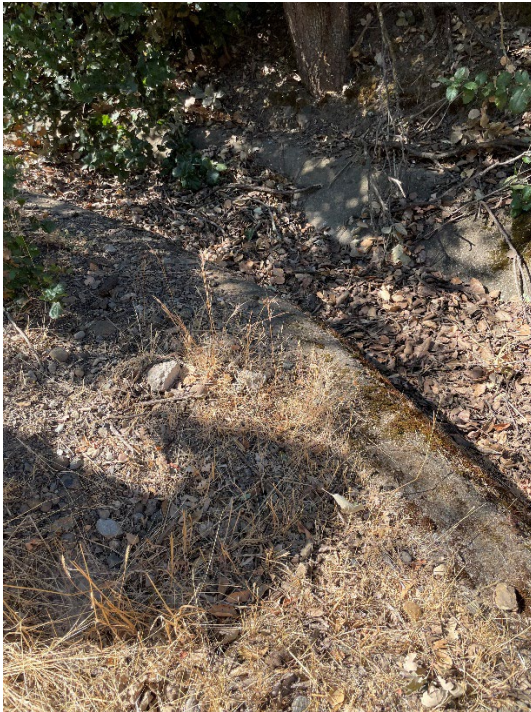
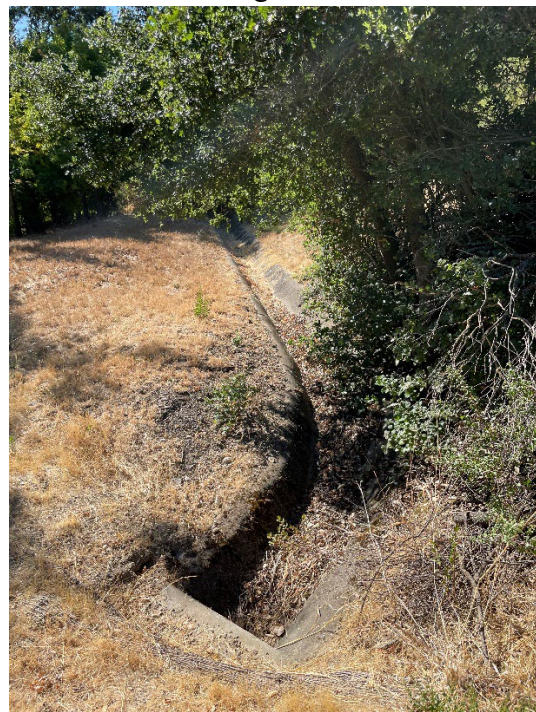
ID OTF-9: Leaves accumulated in concrete drainage ditch.
